Avoiding Flashover in Medium Voltage Switchgear

Chuck Humphrey

Highvec Canada Inc.

UV / CORONA IMAGING REPORT

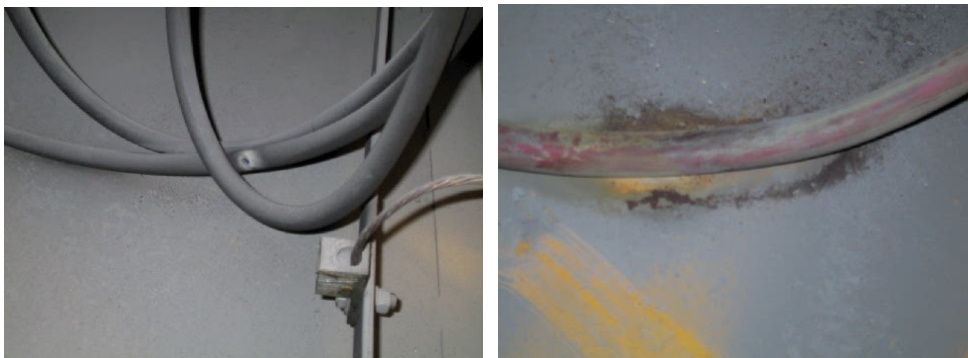
Corona damage is one of the problems that we find on a regular basis. Because of the by-products, nitric acid and carbon produced from the corona discharge a continuous decay of insulation is taking place, which makes the situation highly unpredictable. With corona being the cause of most flashovers in metal clad switchgear you can predict that flashover is imminent in all cases. There are various signs that identify corona, some with no indication of corona using nondestructive testing, but with closer visual inspection we find that corona discharge had been present, but is not active as shown in fig. #1 and fig. #2.

In both these images, flashover was imminent if the problem was not rectified. Even though the corona was dormant at the time of inspection, it would have started discharging again with the appropriate relative air density, temperature, moisture and lack of air movement. Fig. #1 shows insulation decay phase to phase on a 5kv feeder. Figure. #2 shows actual air flow in the dust during corona activity on a 4160v conductor. In this case the deterioration is on the conductor insulation and corrosion on the metal clad.

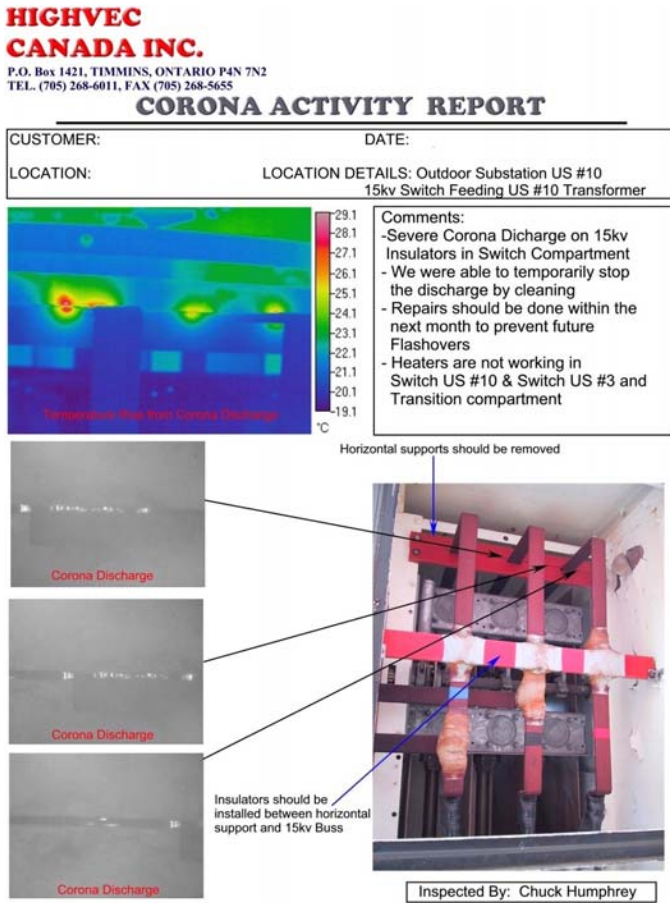
In the case of fig. #3 a thermogram was able to show a temperature rise on the 15kv buss insulators, verified by the ultraviolet corona images. The problem in this case is decay in the horizontal insulators causing electrical stress to initiate the corona. This all started with contamination entering the switchgear, trapping moisture and then under the right conditions started producing corona. Then with nitric acid, ultraviolet light, ozone and carbon deteriorating the insulation the corona eventually spreads on it's own.

Corona at anytime is extremely serious and should be dealt with and eliminated as soon as possible. In our case we can stop the corona with our cleaning equipment. Sometimes permanent and sometimes temporarily, depending on the situation.

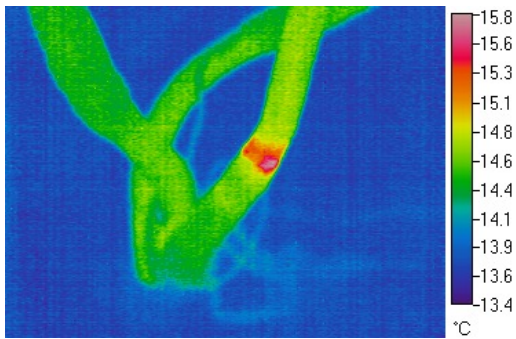
fig. #4

These thermograms represent two different cases of defective stress cones. Fig #4 shows a 5kv shielded cable with a stress cone and fig #5 shows a 15kv shielded cable with stress cone. The temperature rise is minimal, but the problems are very serious. Both stress cones were developing corona underneath the insulation and will eventually flash to ground. I have talked to different electrical thermographers and some believe that if the temperature rise is less than 10 degrees, not to worry about it. As you can see from images #4 and #5 that the temperature rise is less than 2 degrees C .

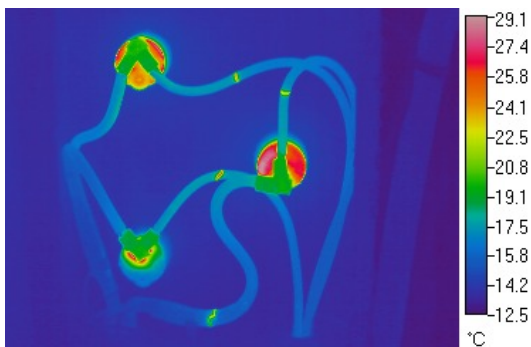
Active corona in fig. #6 shows a 4,160v junction box which is very close to flashover on three phases and had to be rebuilt because the corona damage was too extensive. We were able to temporarily stop the

activity with cleaning which kept it energized until they had a scheduled shutdown. Fig. #7 shows 13,800v conductors and insulators developing a temperature rise from corona discharge.

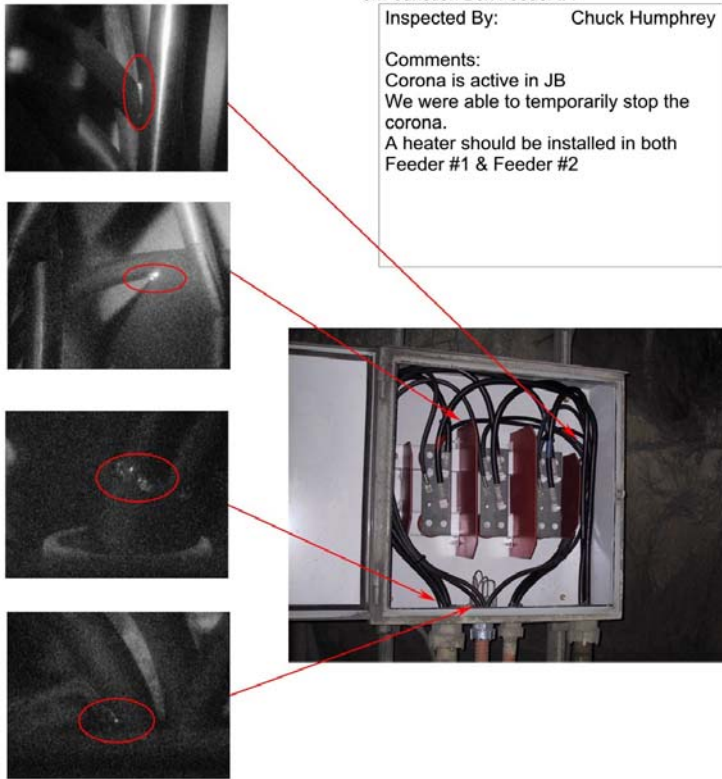
fig. #8

Comments:
Corona is active in JB
We were able to temporarily stop the corona.
A heater should be installed in both Feeder #1 & Feeder #2

Fig. #8 shows a 5kv main feeder for an underground mine. No outage was needed for this corona problem. After we cleaned the junction box and separated the leads, a heater was installed to keep the moisture out.

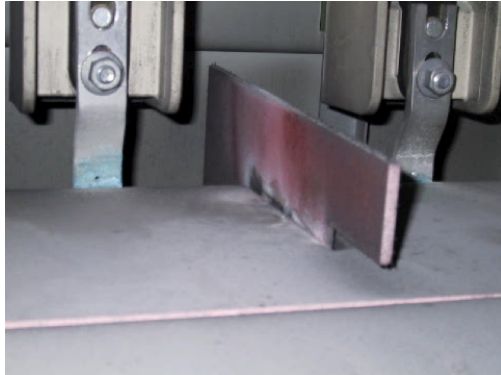
fig. #9

Figure #9 shows severe corona in a 15kv interrupter switch. The green material on the buss bar is corrosion from active corona and the black material on the bakelite insulation is carbon residue from active corona and arcing. This particular switch was very close to flashover.

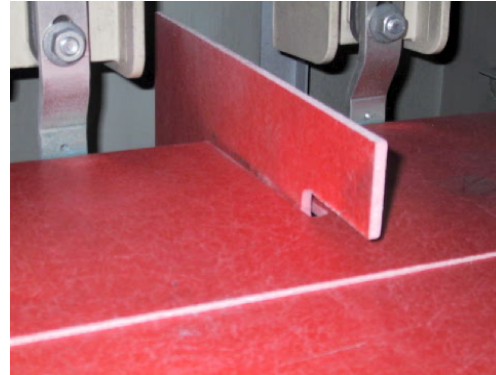
fig. #10

Figure #10 shows what fig. #9 was like after it was cleaned. We were able to stop the corona activity temporarily, to buy time for a scheduled power outage. The problem in this case was the red bakelite divider was tight against the 15kv buss and was starting to short out. The problem was resolved by cutting the insulating divider a couple of inches back from the buss.
