Avoiding Flashover in Medium Voltage Switchgear

Chuck Humphrey

Highvec Canada Inc.

UV / CORONA IMAGING REPORT

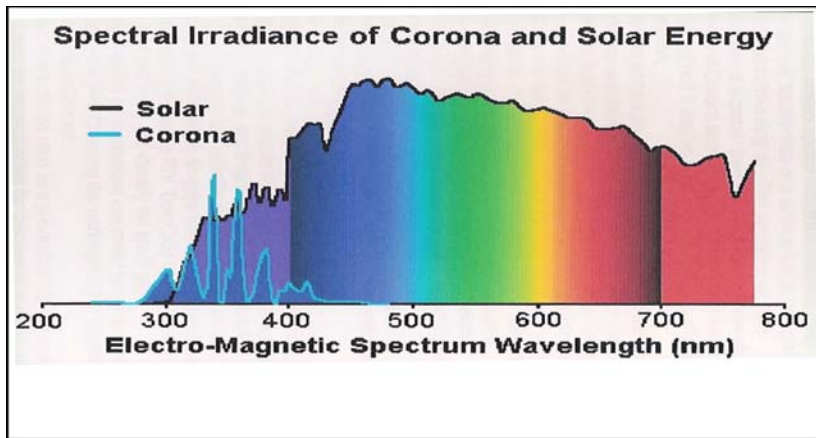
When tracking down corona we have found that it does not always leave a thermal signature. Corona by nature creates little or no heat, but as it progresses into arcing and tracking a thermal signature can sometimes be found. Corona is most intense in the 300 nanometer to 400 nanometer range in the ultraviolet spectrum. When it exceeds the 400nm range corona can be seen in the visual spectrum if there is no interference from background light. Similar to heat coming into the visual spectrum at approximately 585deg. C. at the 700nm level. As shown in fig. #11

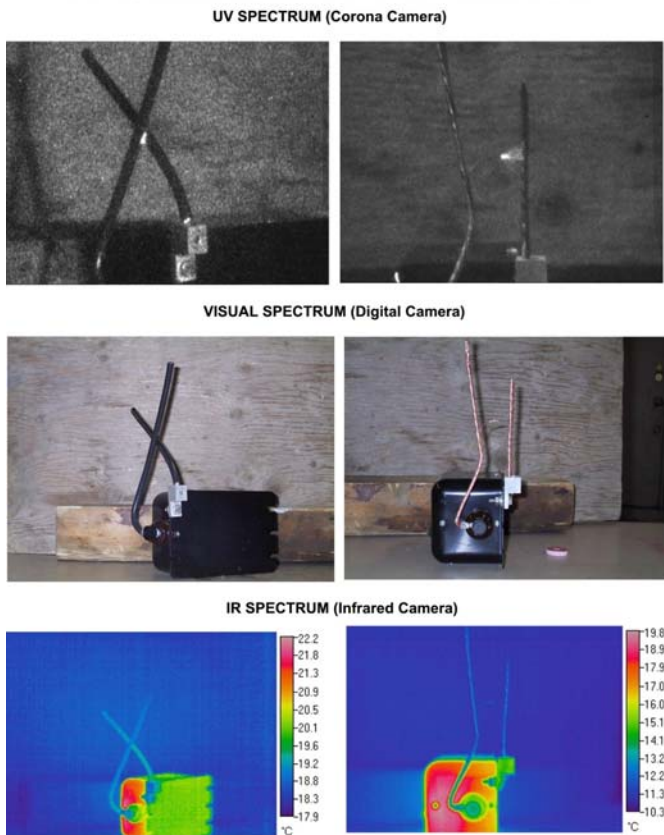
In fig. #12 we show two different scenarios of active corona at 5kv. In the left and right columns we see the three different spectrums all at the same time. At the top we have the UV spectrum using the corona camera and corona is evident. In the middle nothing can be seen in the visual spectrum. At the bottom in the IR spectrum using thermal imaging there is no thermal signature where the corona activity is present.
